LEVEL II
DELAWARE RIVER BASIN
MUSCONETCONG RIVER
WARREN COUNTY
NEW JERSEY

SAXTON FALLS DAM NJ 00277

PHASE 1 INSPECTION REPORT NATIONAL DAM SAFETY PROGRAM

PHASE I INSPECTION REPORT
NATIONAL DAM SAFETY PROGRAM

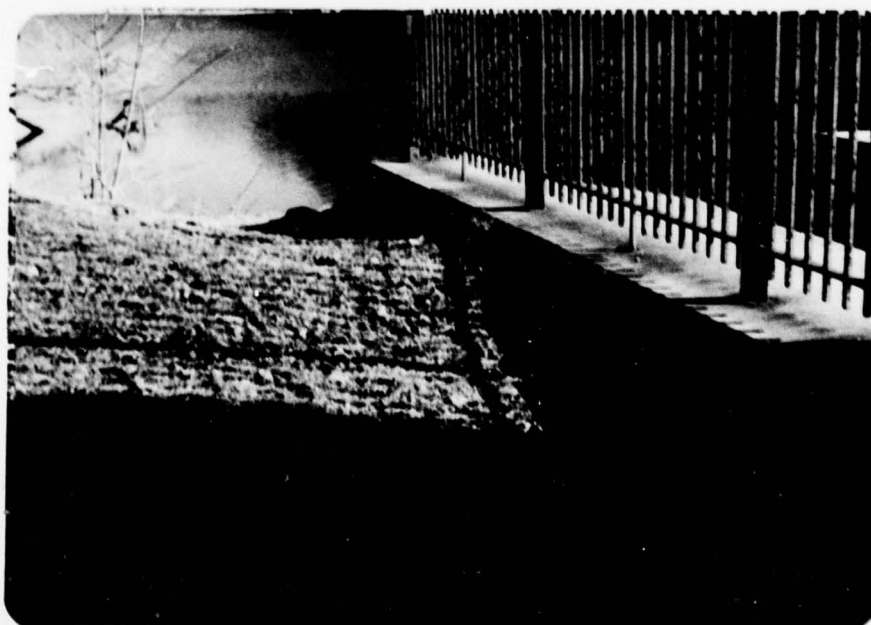
Saxton Falls Dam is 50 years old and is in generally fair condition. A small amount of erosion, 6-in to 12-in, has occurred at both abutments.

Erosion at right abutment immediately north of gate house. 6 December 1978

4. Erosion at the right and left abutment should be repaired and the area suitably riprapped. This should be done soon.
5. The valve for the 16-in-dia CI pipe to the bathing pool should be made functional to increase the low level outlet capacity of the dam. This should be done soon.

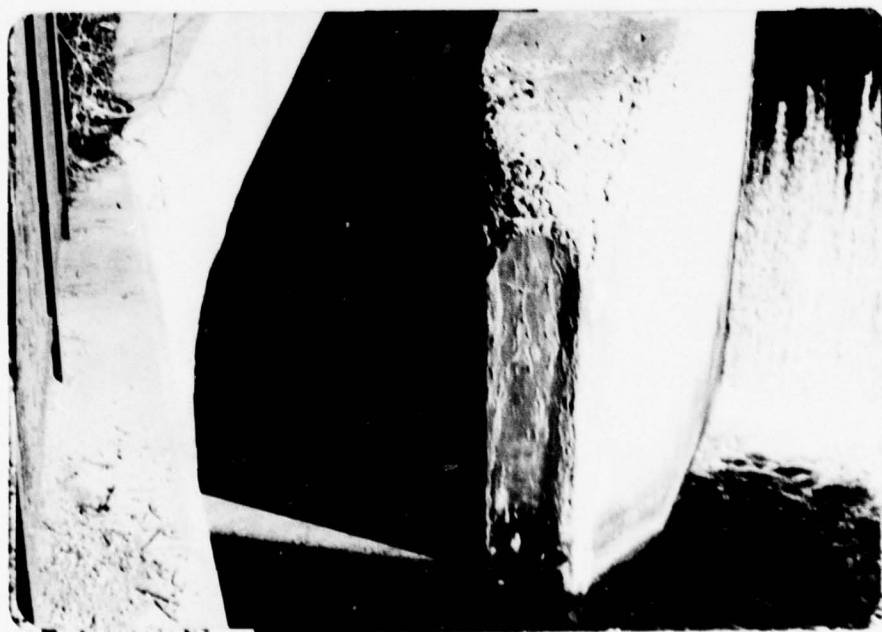
Deterioration of the concrete near the water surface has exposed the aggregate at the sidewall. In addition, the upstream end of the sidewall has minor spalled areas. The inlet and outlet structures of the outlet works are also spalled in a few areas.

Spalled concrete on south wall of gate house discharge channel. 6 December 1978

6. The spalled and eroded areas on the dam and gatehouse structures should be repaired. This should be done in the near future.
7. The spillway capacity as determined by CE Screening criteria is inadequate. The actual capacity of the spillway and the SDF should be determined using more precise and sophisticated methods and procedures. The need for and type of mitigating measures should be determined. Around the clock surveillance during periods of unusually heavy precipitation should be provided, and a warning system established. This should be done in the near future.

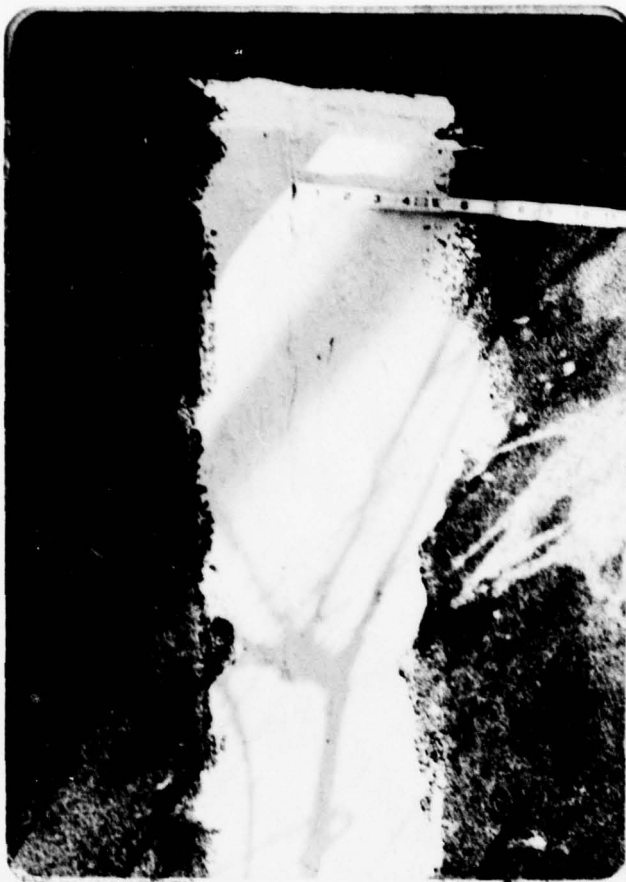
The sidewall at the left abutment of the dam appears to have settled a small amount at its upstream end, resulting in a vertical crack through the entire width of the sidewall approximately seven (7) feet upstream of the dam

face. The width of the crack is approximately 1/2 inch at the top of the wingwall and becomes narrower as it proceeds downwards. It has been repaired recently by a local resident and movement has occurred since its repair.

Recently repaired crack in left
sidewall of spillway.

1. The crack in the left sidewall should be investigated and repaired. The investigation should include borings and be made in such a manner as to provide information leading to an understanding of the cause of the crack and the type of repair and strengthening of the wall that is necessary. This should be done very soon.

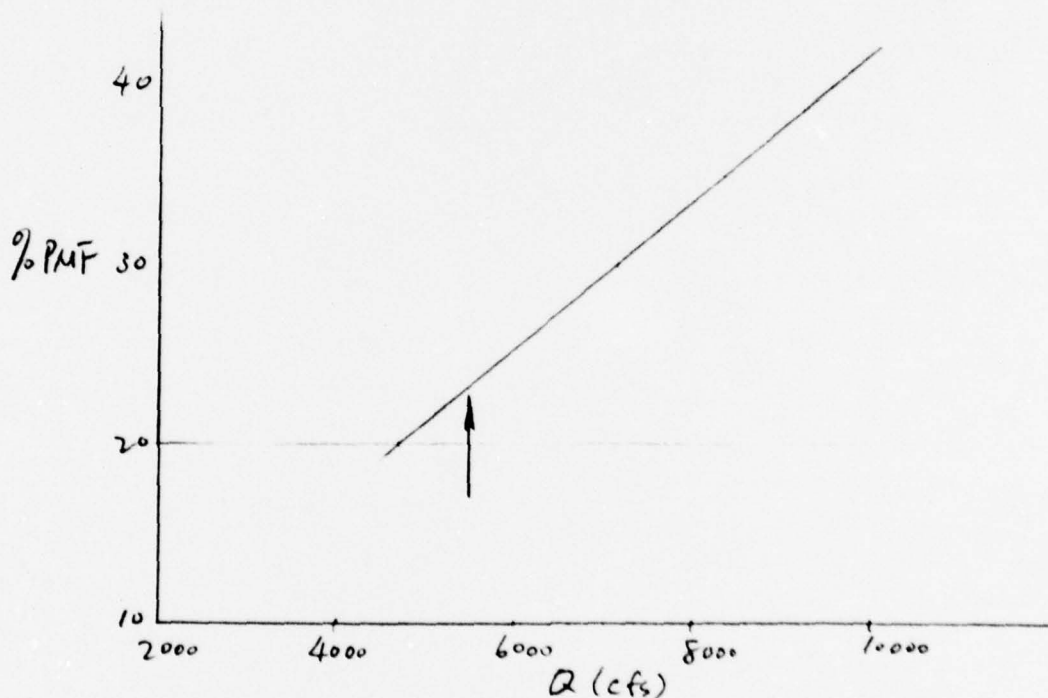
OVERTOPPING POTENTIAL

3. Dam overtops at approx. El. 97-55 with $Q = 5474$ cfs.
 i.e. dam can pass approx. 23% of PMF
